An Architect's
Analysis of the Property of
Mr. Douglas Kirk

Ronald F. Avery
Architect
February 15, 2019

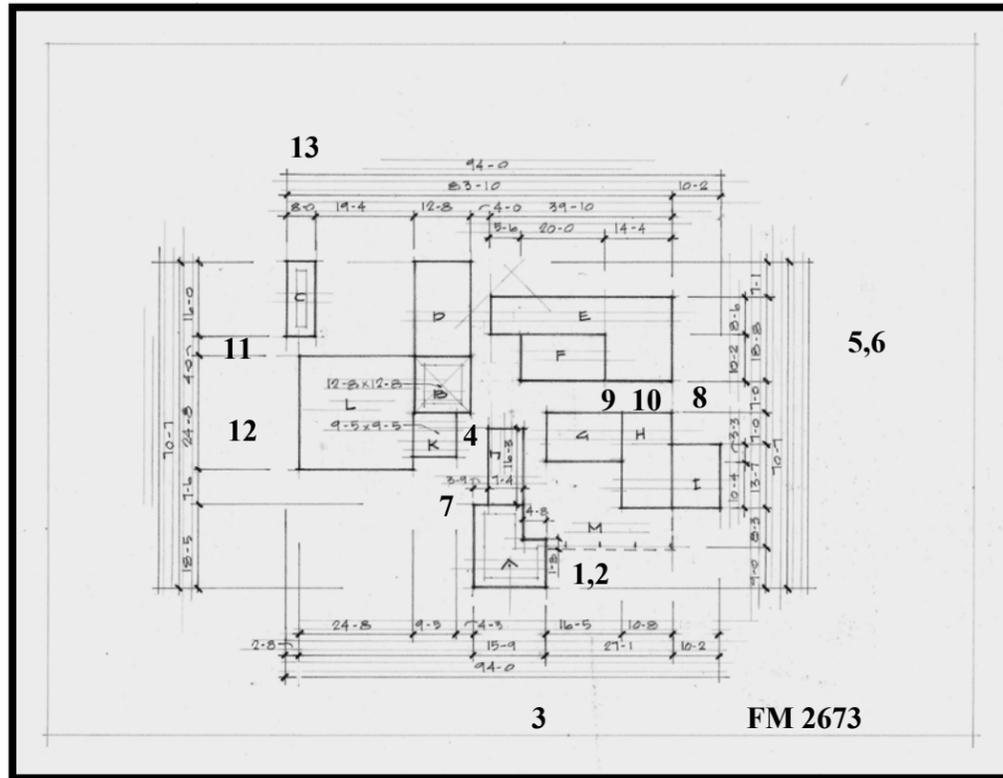
FIREWORKS STAND

Much is open to the air and shows signs of water damage on eaves and fascias. Roofs leak.

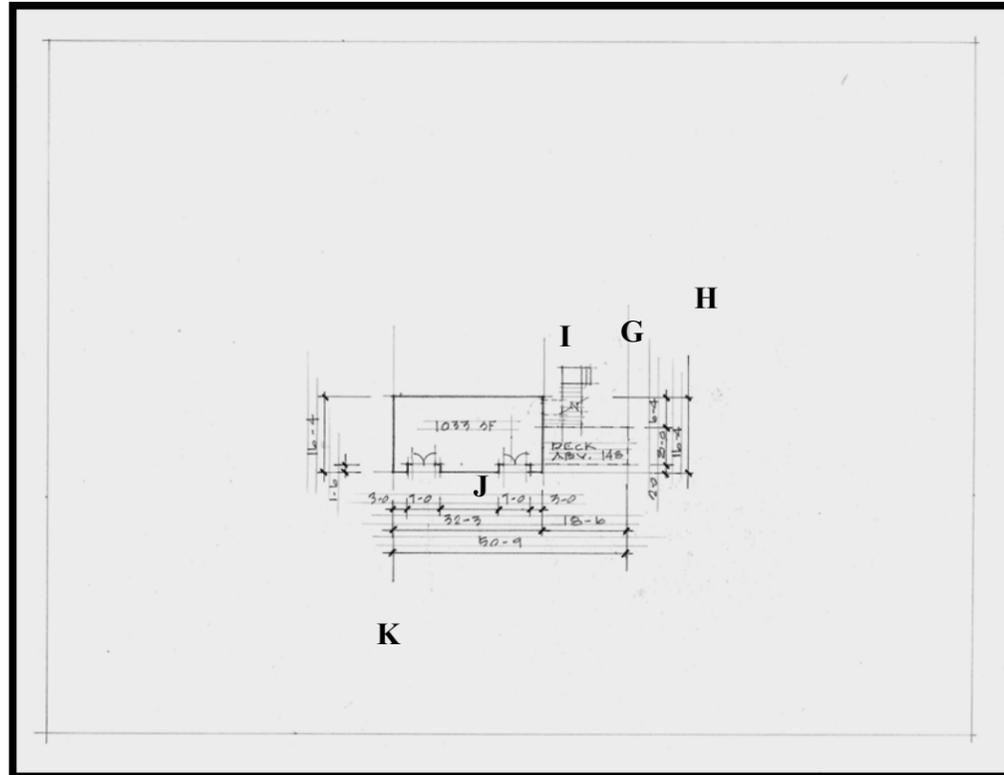
ABANDONED OFFICE

Condition:
Unfinished. Built 38 years ago by present owner in 1981 without construction experience. It shows signs of siding and parapet rot. Severe roof damage caused owner to abandon it. There are no interior stairs to get to 2nd floor. Deck was in-

stalled after first exterior stair collapsed. Roll vinyl flooring separating from plywood subfloor. No interior finish on 2nd floor.

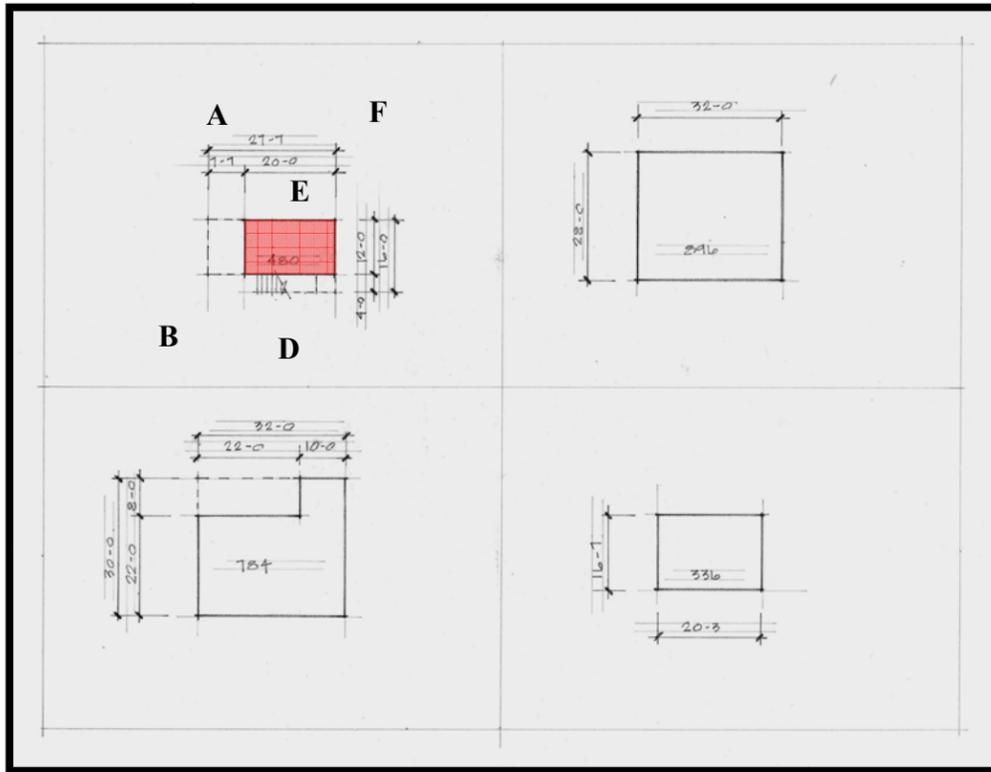
ABANDONED ORIGINAL SHELTER

Condition:
Major leaks caused ceiling collapses and damaged contents. The exterior doors & stairs are rotting. There is no kitchen but has a very small non-functioning bathroom. The front porch is rotted out and the porch deck has collapsed.

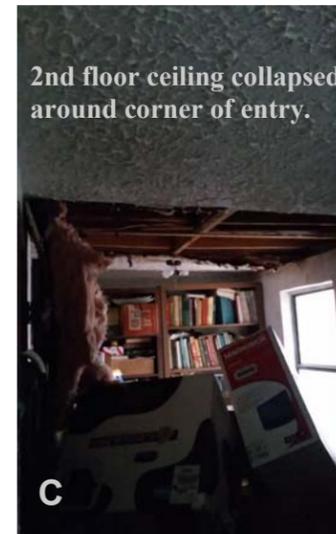
2nd floor ceiling collapsed around corner of entry.

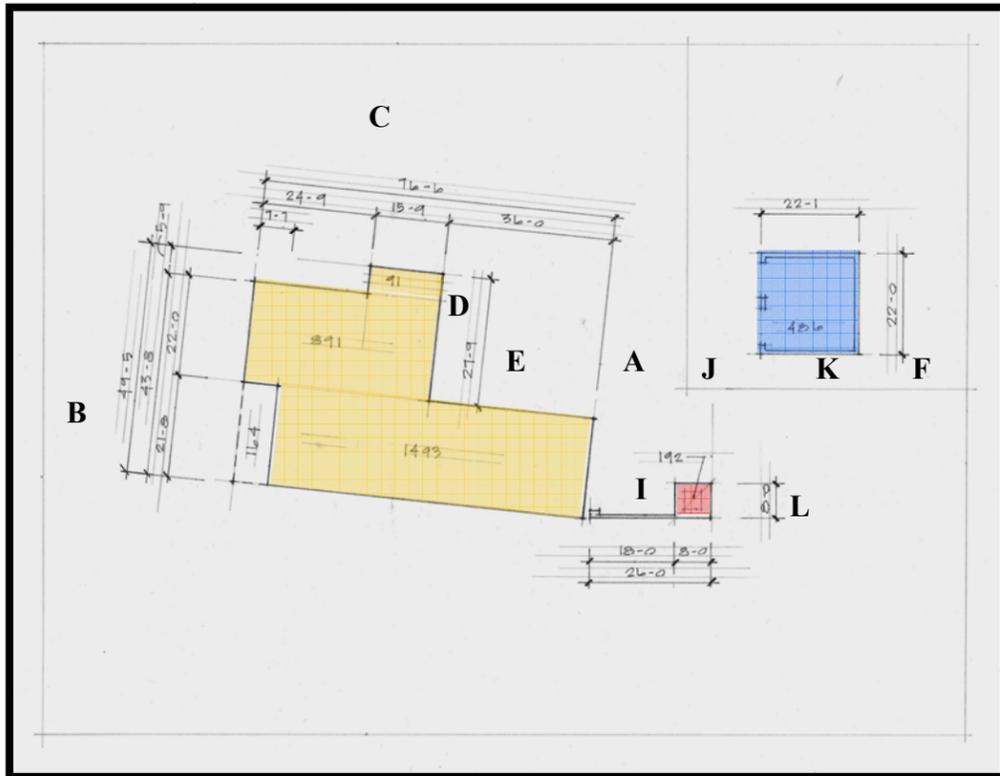
TOWER & STORAGE

The tower is open to the weather and

several of the treads of the internal ship's ladder are missing with exposed nails showing. The storage shed has open gaps in the walls and no interior finish.

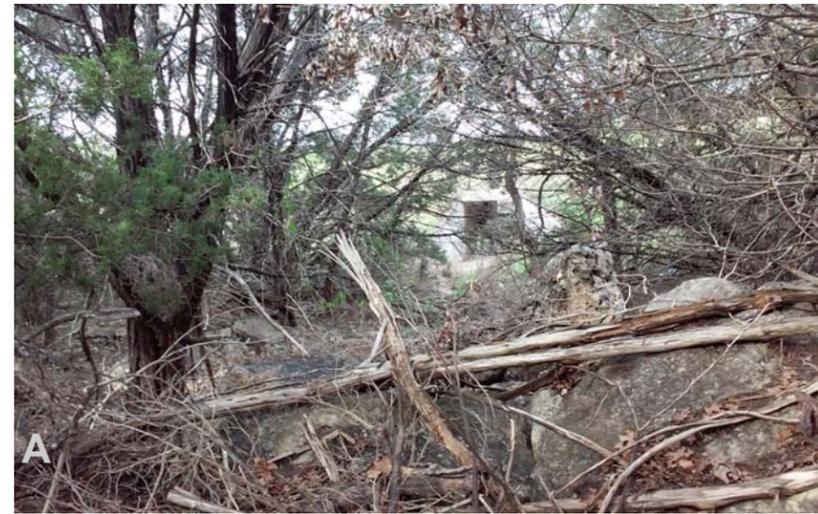
A
View from bottom of channel 2 towards Culvert.

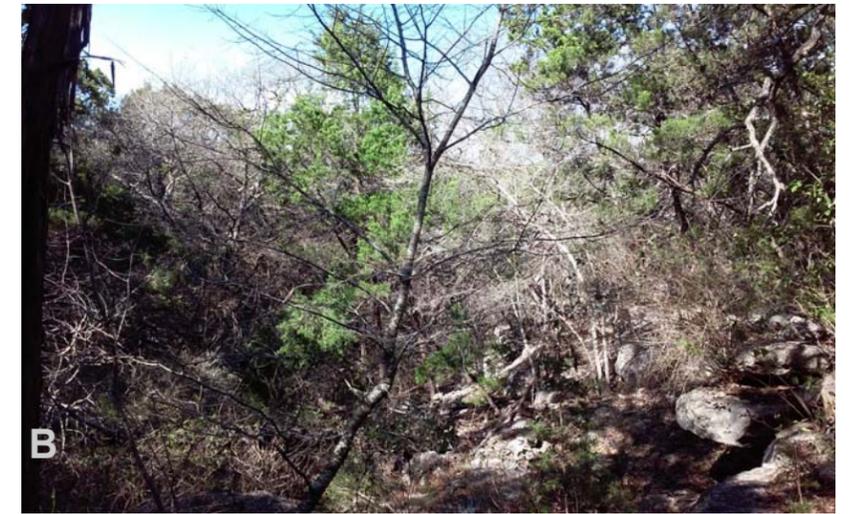
B
View of heavy erosion near the top of channel 2.

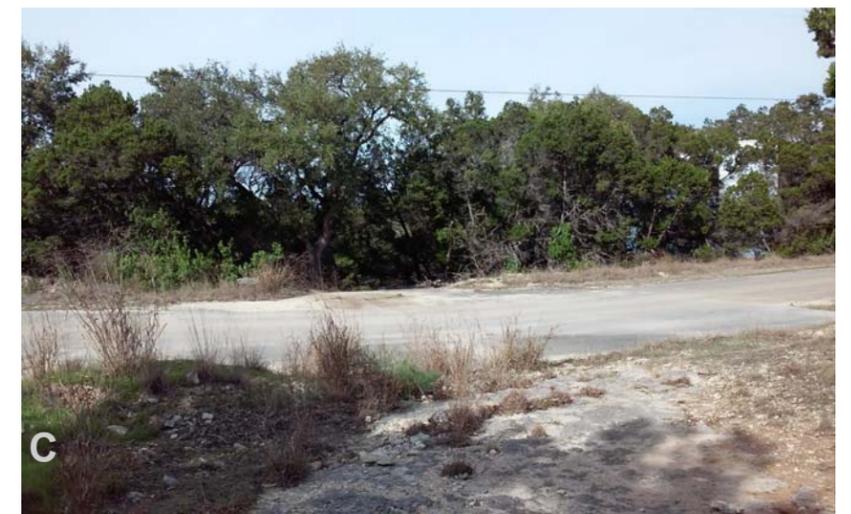
C
View of low water crossing of Old Sattler Rd. into property.

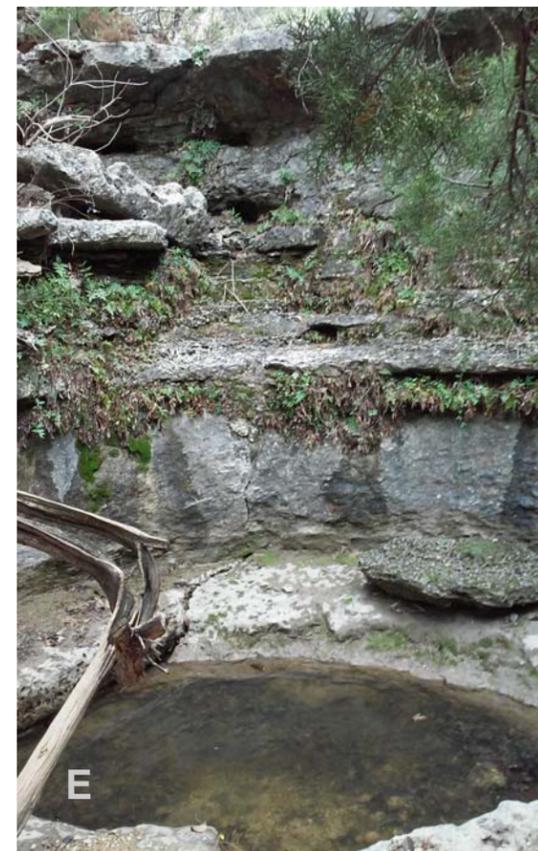
E
Water pooled in deep channel.

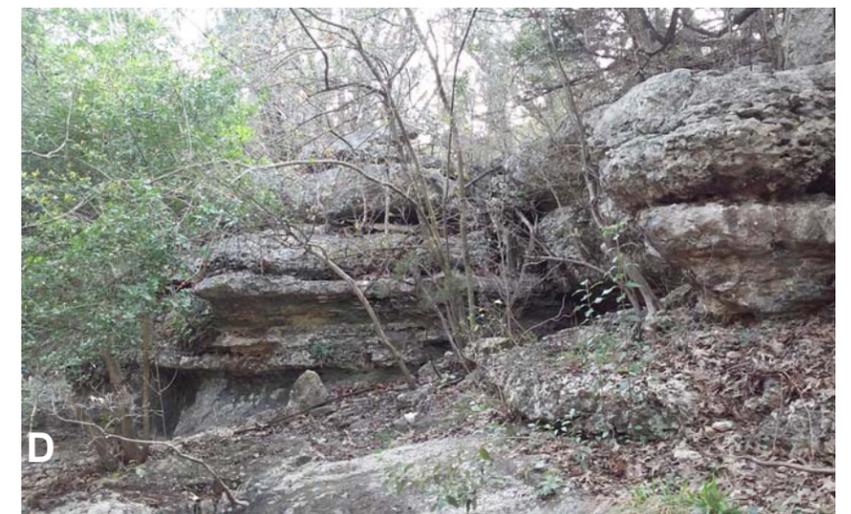
D
Deep erosion in channel nearing 20 feet high.

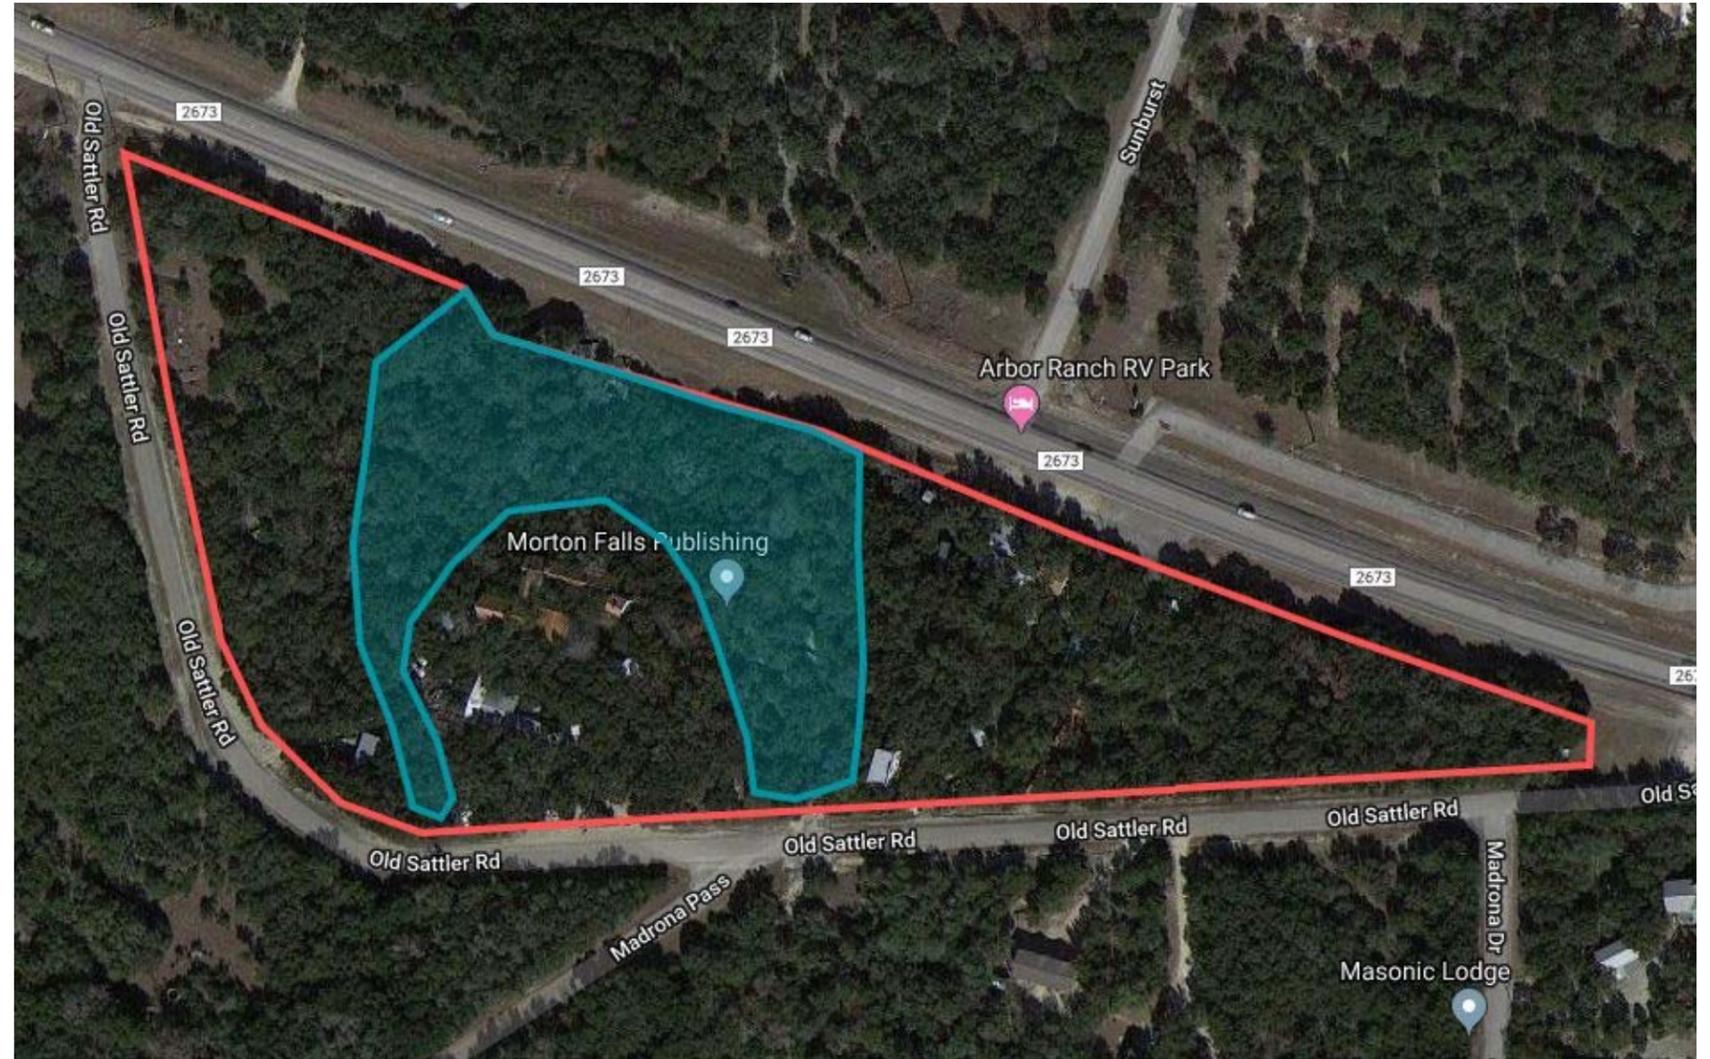
The blue area is a rough approximation of the perimeter of the area of deep erosion from runoff. Google reports the graphic includes 2.88 acres.

This would amount to at least a 29 percent reduction in the value of this land. Given that the CAD says the land should be valued at about \$133,000 then it should be reduced by 29% or a reduction of \$38,570 totaling **\$94,430**.
