An Architect's
Analysis of the Property of
Mr. Douglas Kirk

Ronald F. Avery
Architect
February 15, 2019

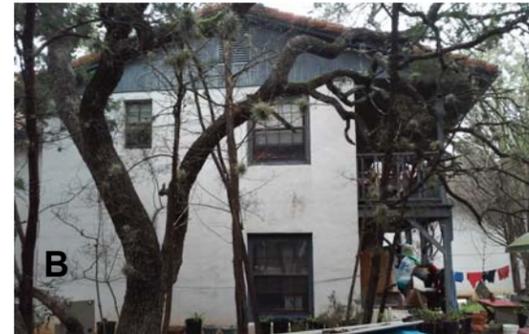
B

Condition:
 Home was built by the present owner who is not a builder with experience in the building field. It is unfinished and plumbing is in bad shape, bare plywood floors upstairs, Tile is coming up in

places downstairs due to slab cracks. Stairs have open risers and no finish. Wood trim is rotting. Clothes dryer is broken. Barrels are intended for future roof rain water collection system.

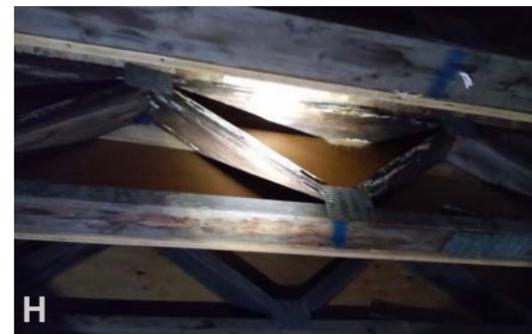
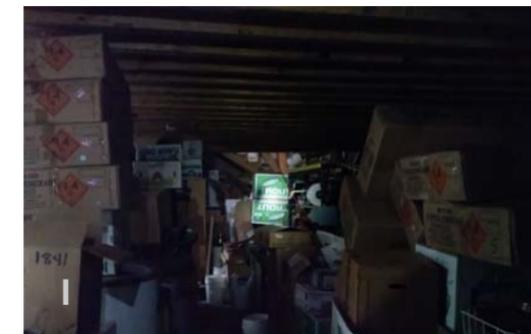
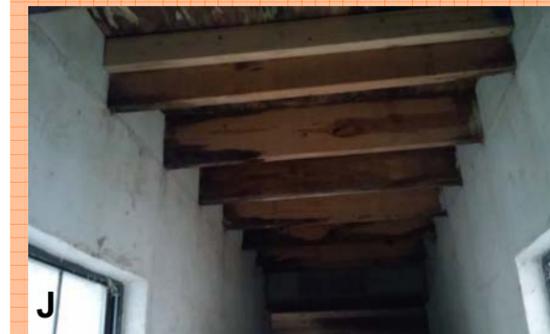
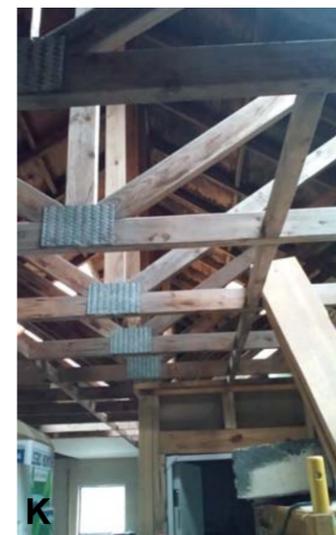
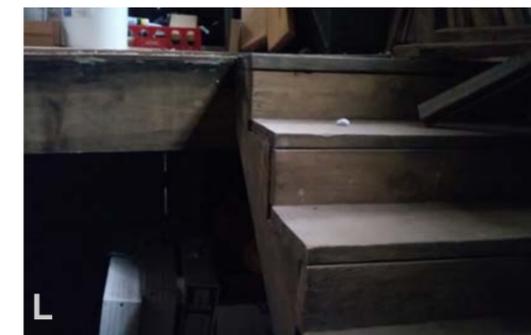
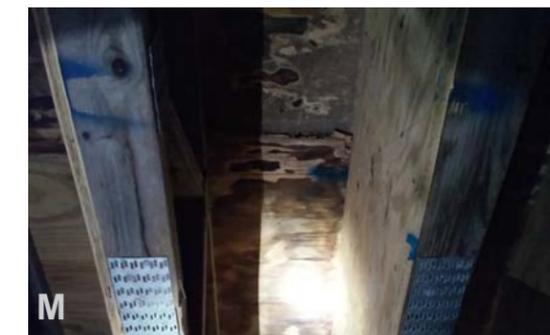
Unfinished and in disrepair. Water damage from previous roof leaks. Plywood was used to strengthen water damaged trusses. Exposed Plywood floors show signs of previous water damage due to years without roof.

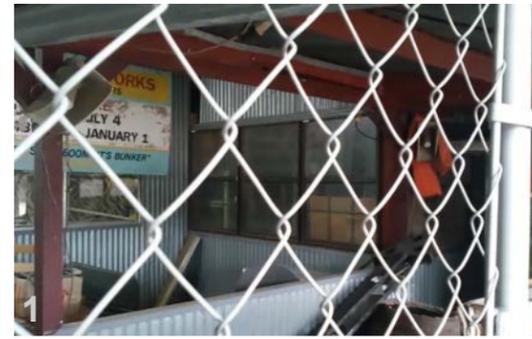
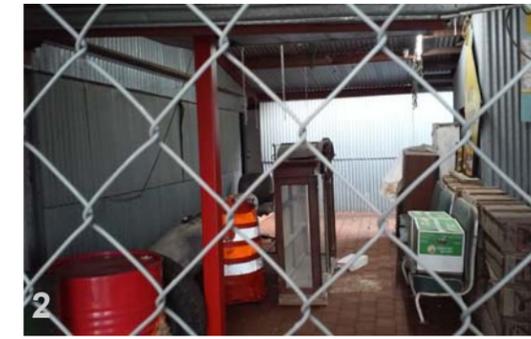
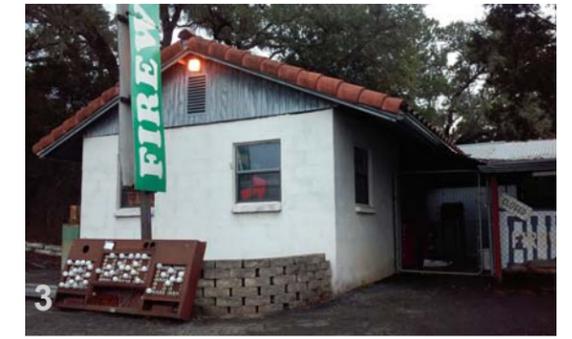
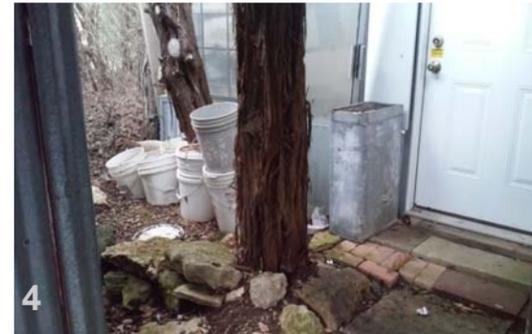
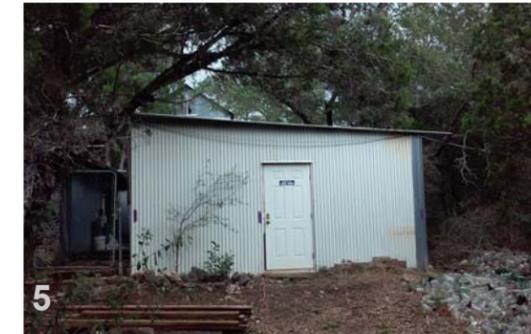
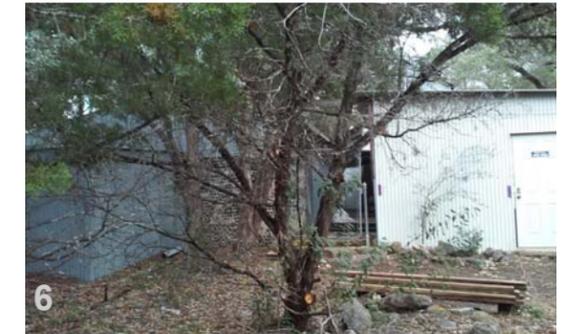
FIREWORKS STAND

Much is open to the air and shows signs of water damage on eaves and fascias. Roofs leak.

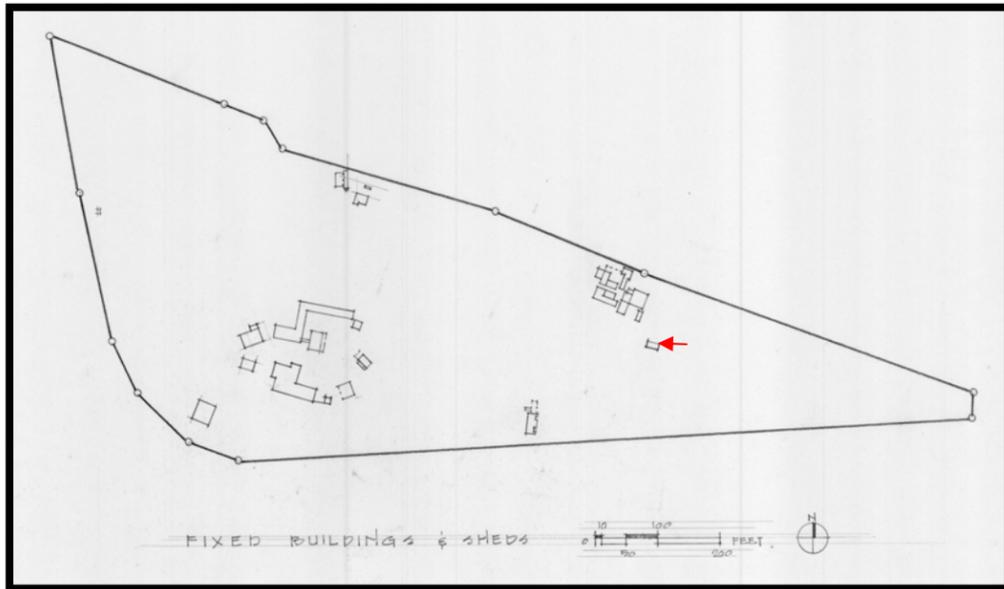
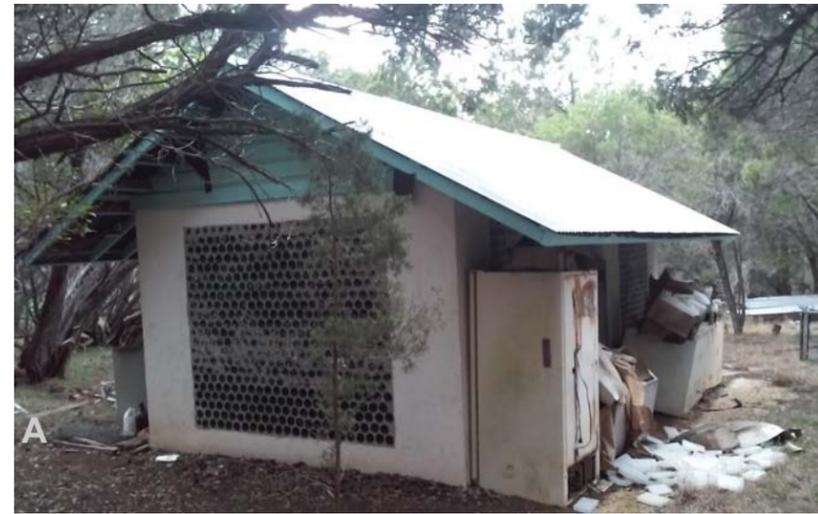
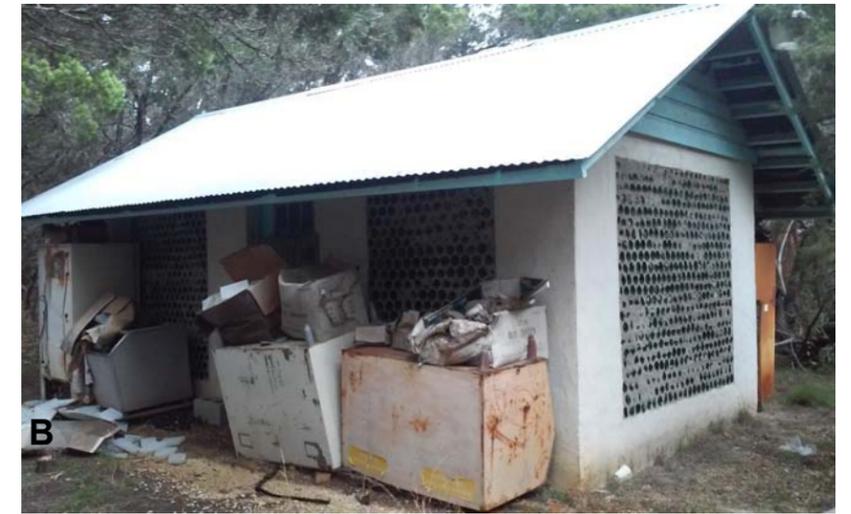
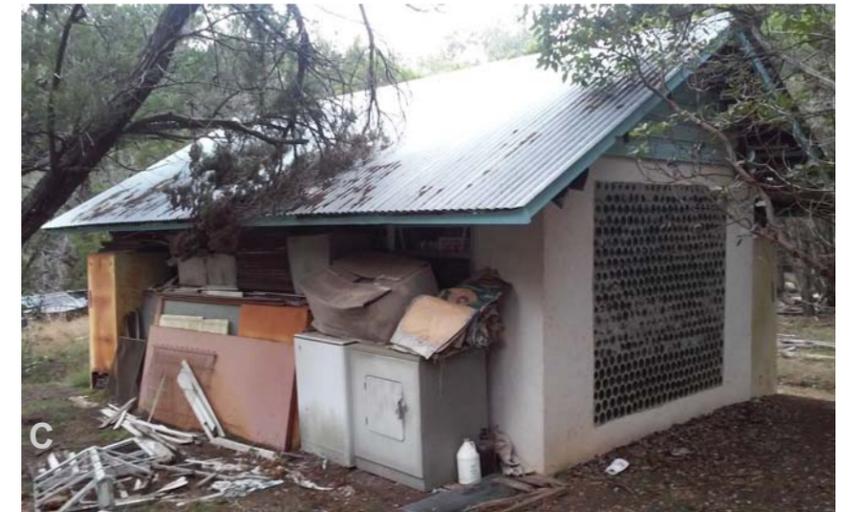
Bottle Wall CMU Building

Infill between CMU blocks is bottles laid in place with concrete.

Condition:
Unfinished with residual concrete on bottles.

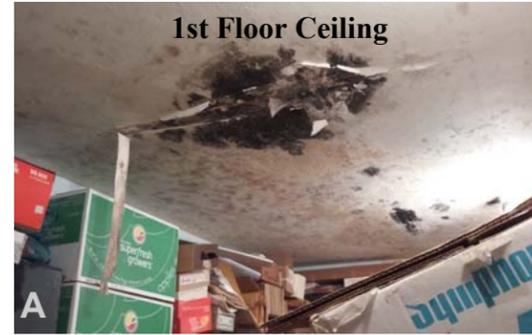
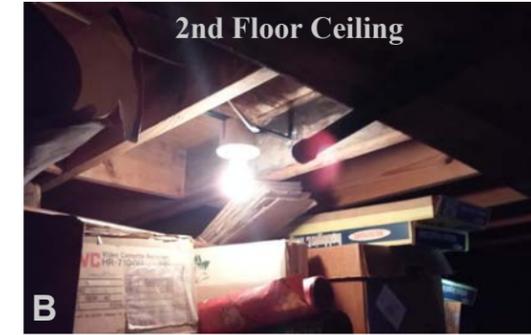
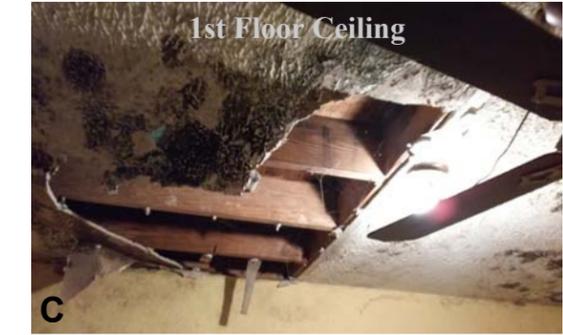
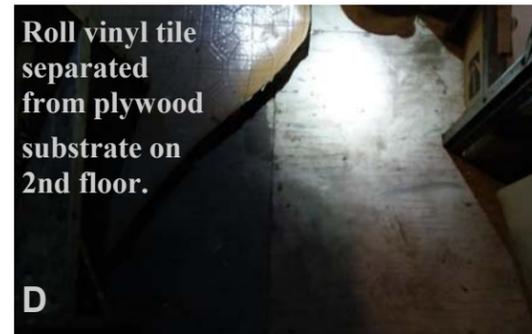
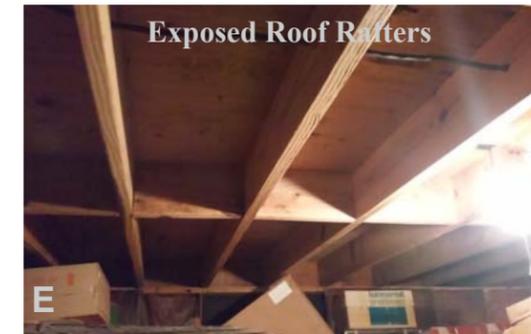
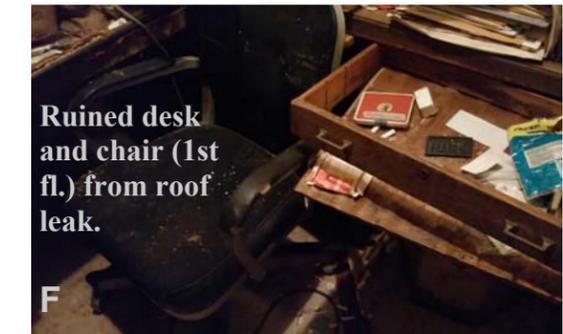
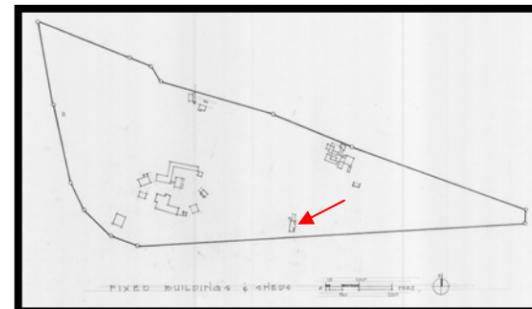
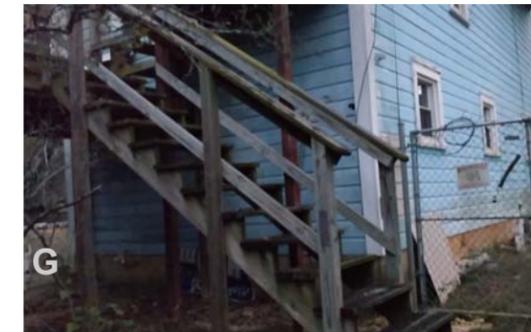
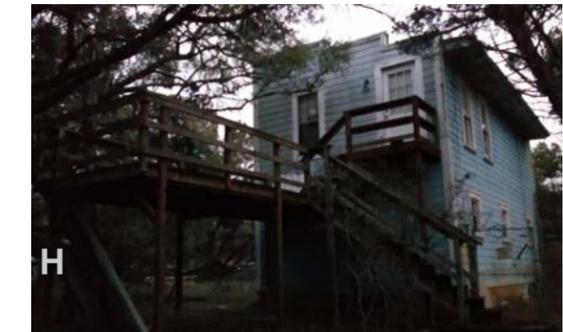
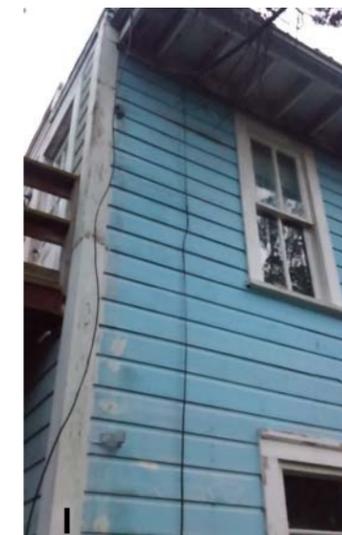
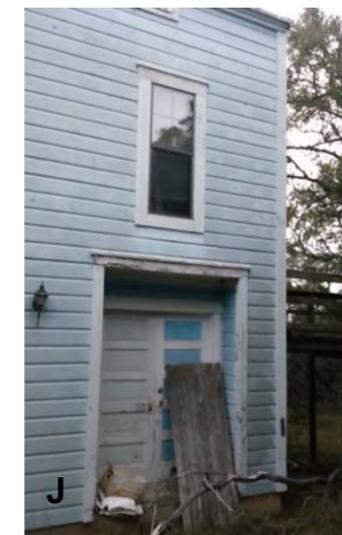
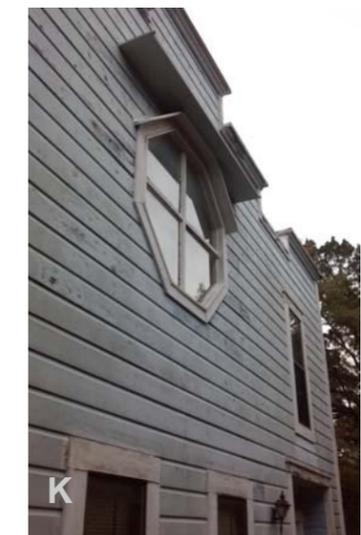
ABANDONED OFFICE

Two story structure was built by present owner, who had no experience in the building trades and abandoned after serious roof leaks.

Condition:
Unfinished. Built 38 years ago by present owner in 1981 without construction experience. It shows signs of siding and parapet rot. Severe roof damage caused owner to abandon it. There are no interior stairs to get to 2nd floor. Deck was in-

stalled after first exterior stair collapsed. Roll vinyl flooring separating from plywood subfloor. No interior finish on 2nd floor.

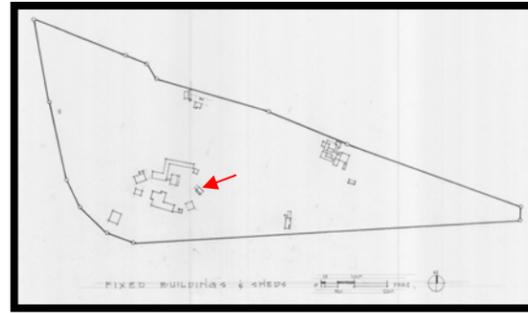
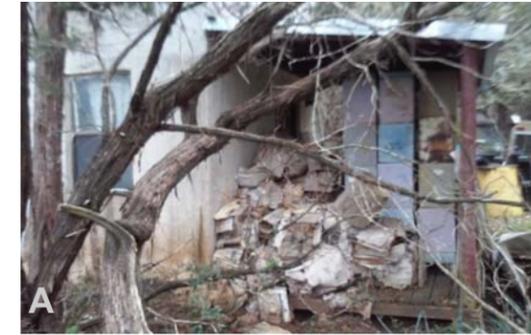
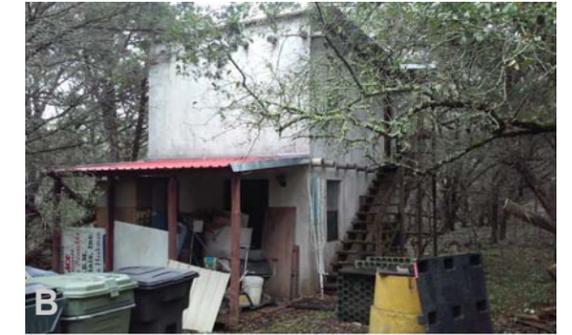
ABANDONED ORIGINAL SHELTER

Condition:
Major leaks caused ceiling collapses and damaged contents. The exterior doors & stairs are rotting. There is no kitchen but has a very small non-functioning bathroom. The front porch is rotted out and the porch deck has collapsed.

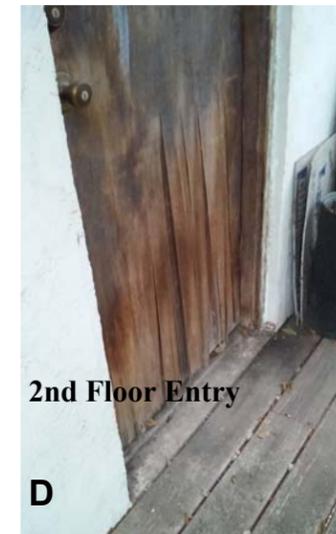
2nd Floor Entry

2nd floor ceiling collapsed around corner of entry.

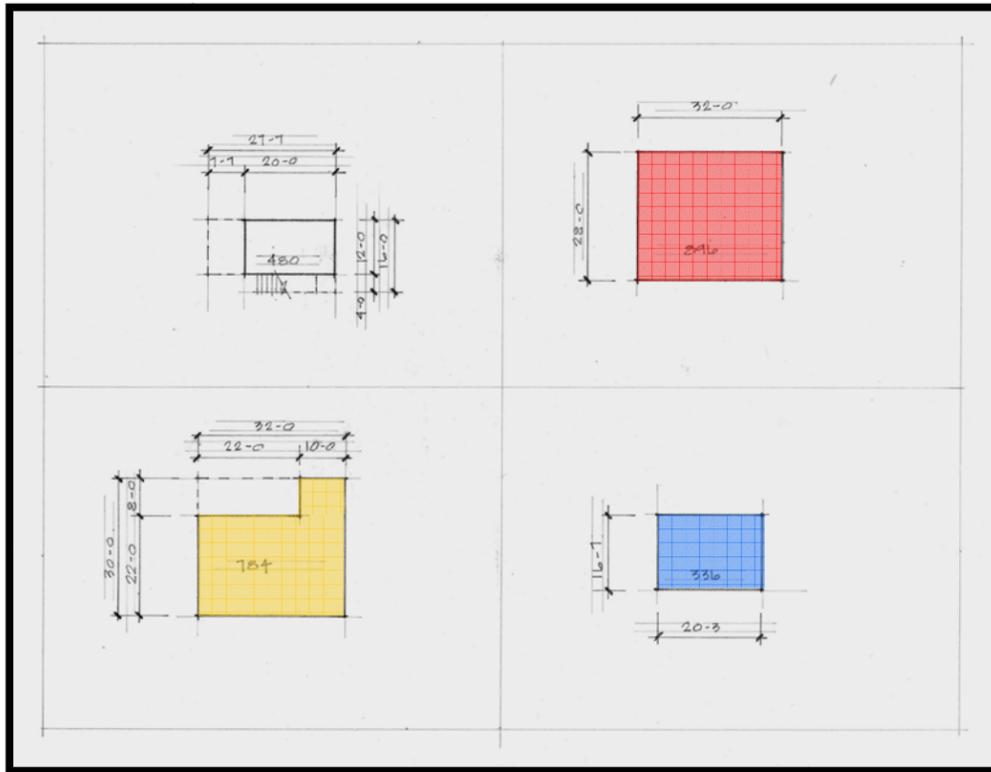
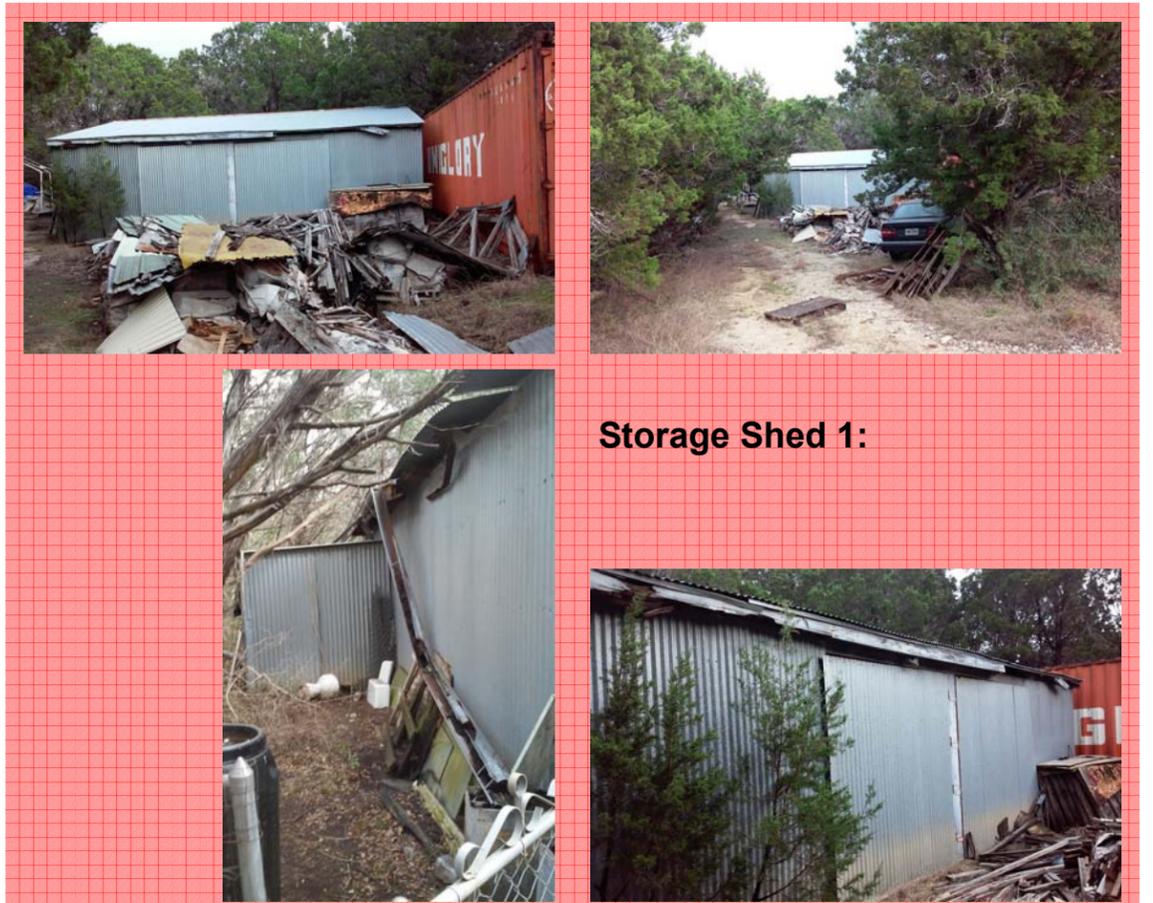
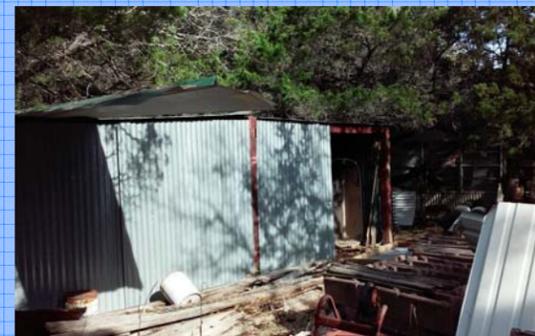
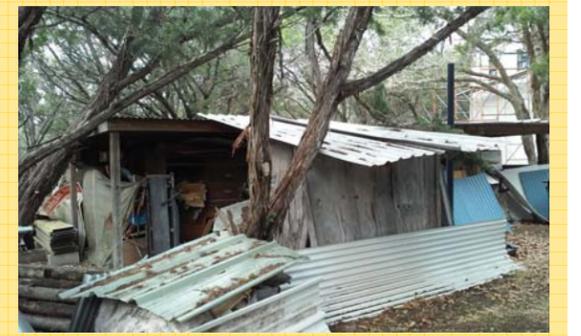
THREE STORAGE SHEDS

Condition:
 Very poor.

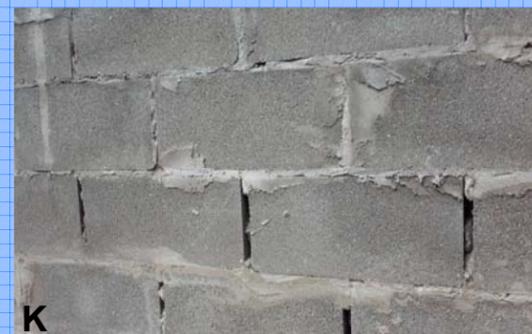
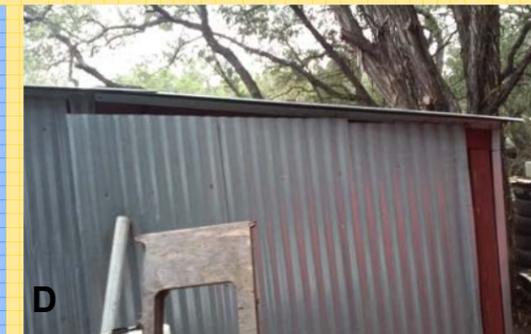
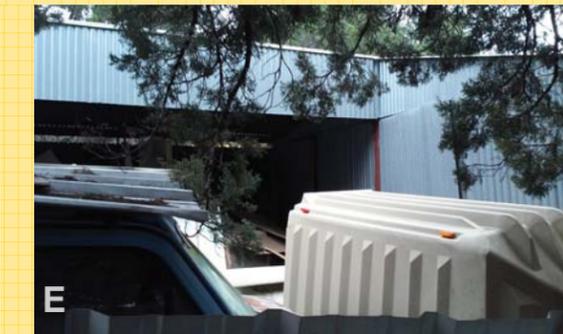
TOWER & STORAGE

several of the treads of the internal ship's ladder are missing with exposed nails showing. The storage shed has open gaps in the walls and no interior finish.

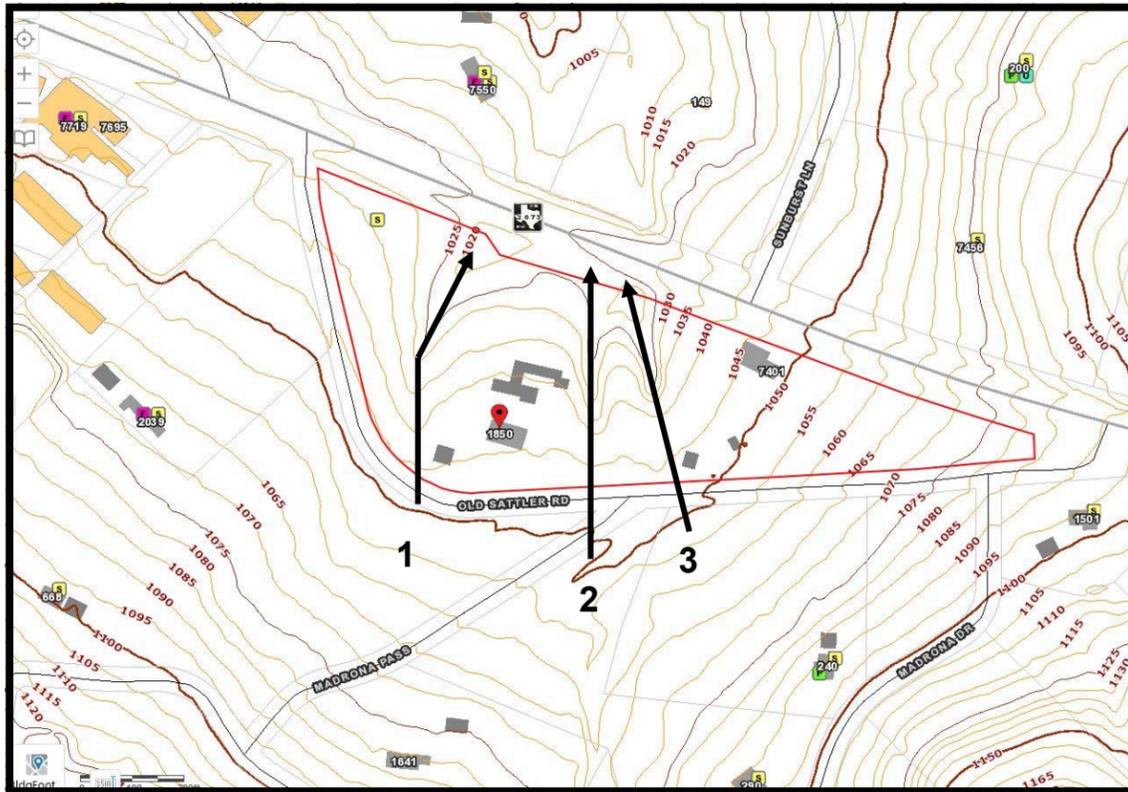
A
View from bottom of channel 2 towards Culvert.
